# ► Monument Conservation

**WEBAC®**

# Contents

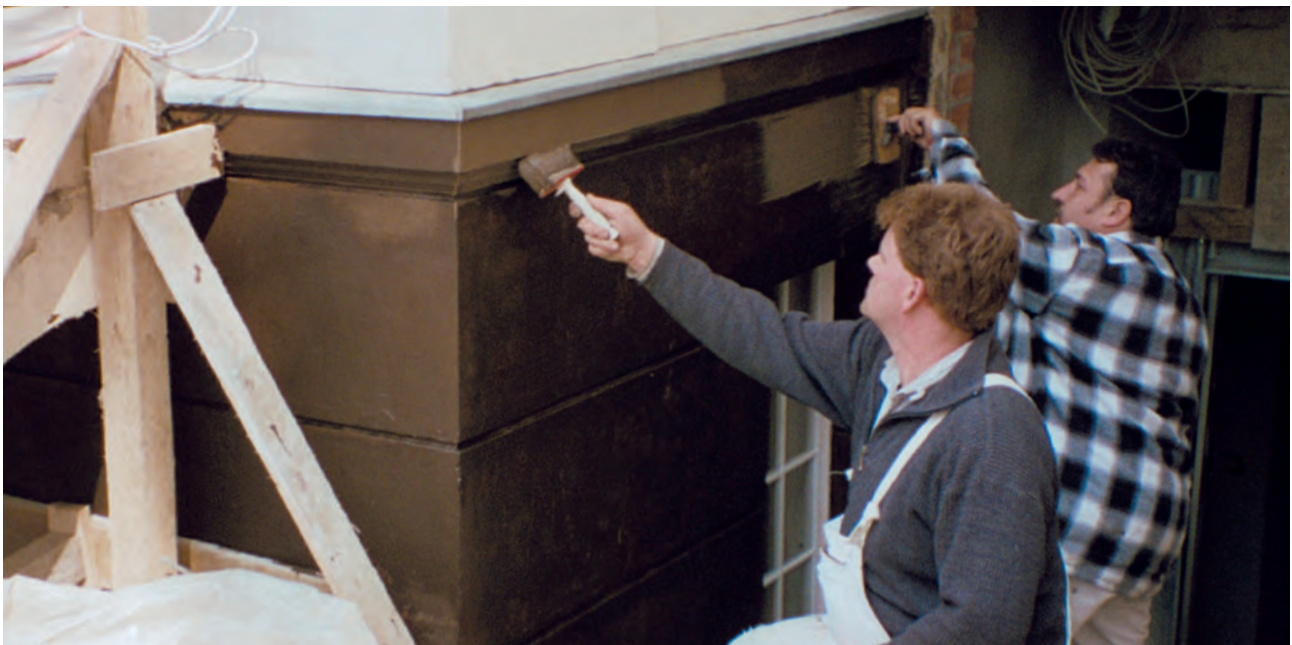
► Special reactive bituminous acrylate sealants are used for sealing surfaces of structures in ground contact or freely accessible structures. These systems also resist high water loads and are especially suited for use in monument preservation.

Polymer modified bituminous thick coatings (PMB) are used for (classic) surface sealants in structures. Reinforcement fabric is used as reinforcing material in the area of joints and for bridging cracks.

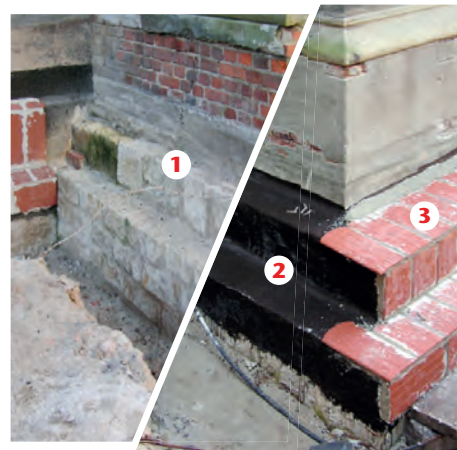
### Plinth sealing

against soil moisture/surface water

- 1 Wall structure exposed, surface leveled out
- 2 **WEBAC 5611** applied
- 3 Fair-faced wall laid with roofing tiles

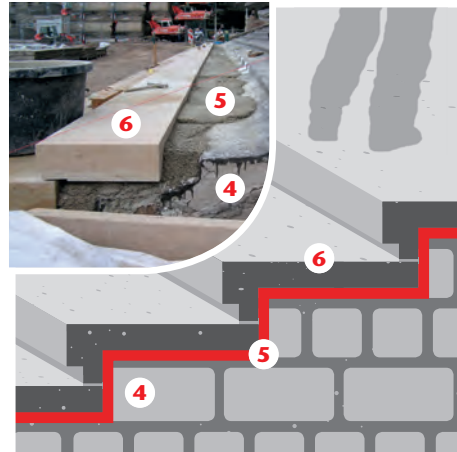
### Damp proof course (dpc) below stair covering

against surface water

- 4 Base structure exposed, surface leveled out
- 5 **WEBAC 5611** applied
- 6 Stairs laid with covering

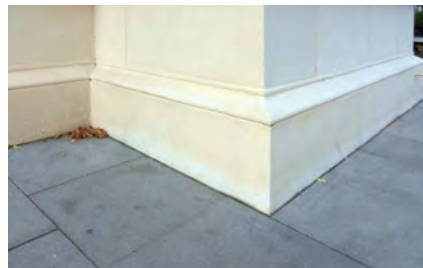
*Permanent sealing of plinths  
against surface water*

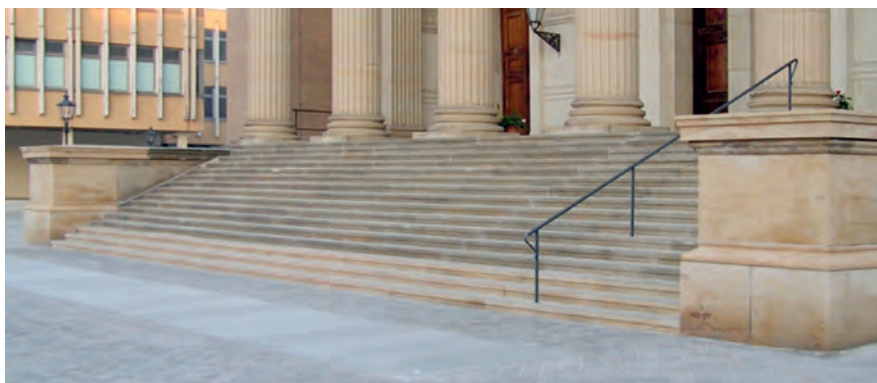
*Freshly restored  
natural stone stairs*

In 2010, the reconstruction measures on the outer shell were completed. Damp proof courses (dpc) were installed in the foundations up to the plinth end, below the natural stone stairs and below the accessible roof area to prevent surface water from penetrating.

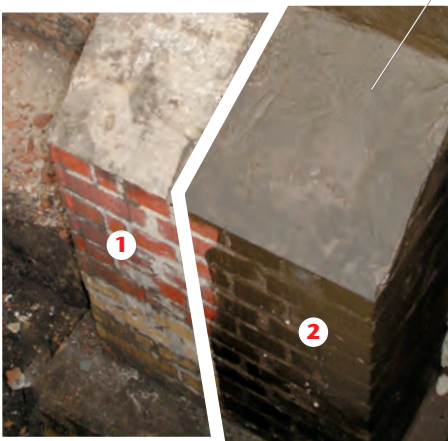
## Bonded waterproofing

against pressing (ground) and surface water

- ① Masonry exposed and jointing repaired
- ② **WEBAC® 5611** applied
- ③ Fair-faced wall laid with roofing tiles to protect the sealant

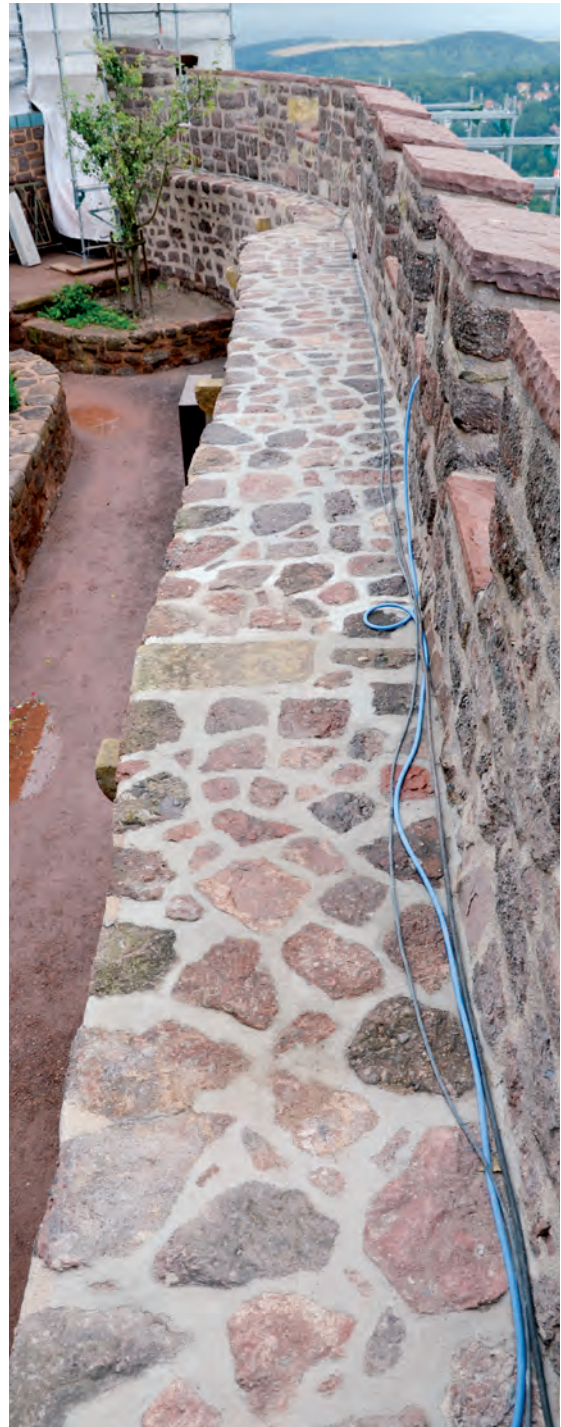
### Sealing of joints

against surface water and moisture penetration

- ① Mortar removed from joints (3 – 5 cm deep)
- ② **WEBAC. 5611** applied (in at least 2 layers)
- ③ Joints jointed anew  
(mortar according to formulation)

For the restoration of the defense wall the mortar was first removed from the joints down to approx. 5 cm and **WEBAC. 5611** was applied to the jointing mortar and the natural stone joint surfaces. The joints were jointed anew with mortar afterwards and the bond area sealed such that surface water could no longer penetrate.

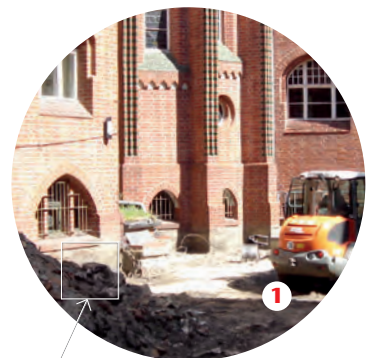
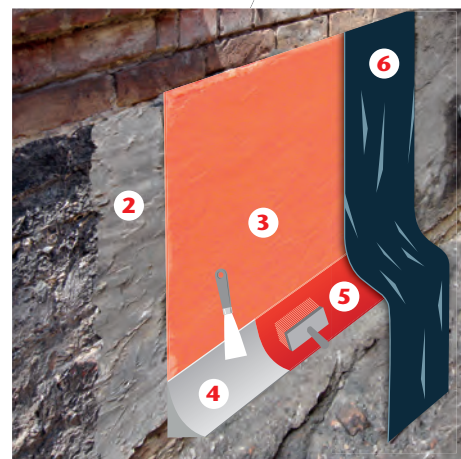
## External sealant on top of old sealant against pressing groundwater

- ① Soil excavated, dilapidated structural elements removed
- ② Sealing surfaces cleaned
- ③ Use of **WEBAC® 5611** without cement as primer
- ④ Concave molding
- ⑤ **WEBAC® 5611** (1 mm film thickness) applied
- ⑥ Protective layer

left strip: old PAH sealant

During an examination of the external sealants in the town hall courtyard, damage to the tar-containing/bituminous old PAH sealant was noticed. Polycyclic aromatic hydrocarbons are carcinogenic and toxic and therefore harmful for humans and the environment. Installing a new external sealant resistant to pressing water would have meant completely removing the old sealant, which would have been very time-consuming and costly.

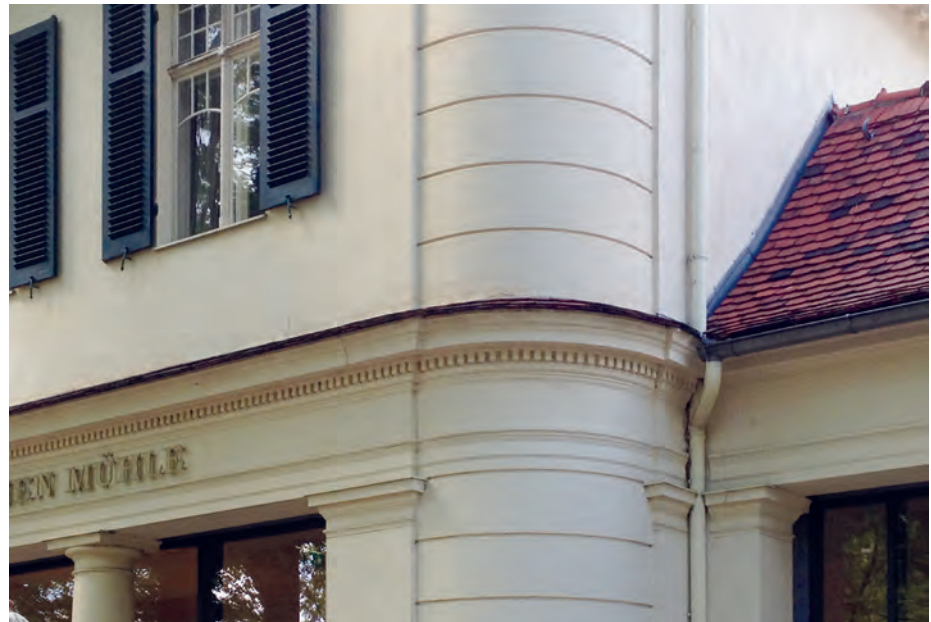
Part of the historical facade coating was provided with a reversible protection

The conversion and restoration of the listed building began in 1998. The basement wall structure, the column pedestal and the spray water plinth were sustainably protected from moisture penetration. Within a representative partial area, the historic facade coating had to be provided with a reversible protection. The spray water plinth was protected in accordance with these requirements together with the exterior wall sealing.

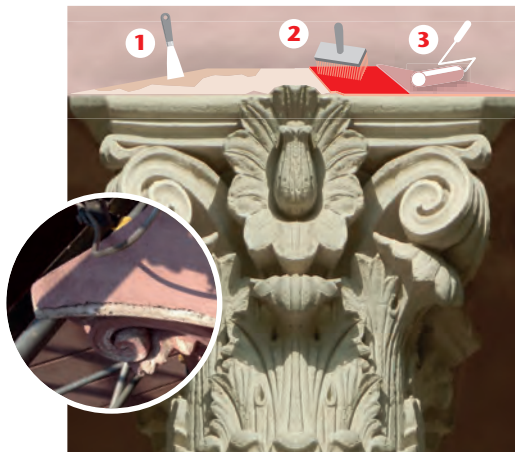
### Seal in the composite below facade paint

against rainwater (surface water)

- ① Column capitals reprofiled and leveled
- ② **WEBAC. 5611** applied
- ③ Facade painted

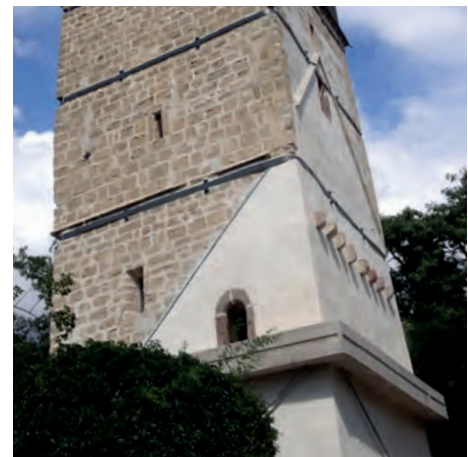
*New gypsum render on the inclined wall surface*
